July 16, 2019

Subject: Cedar Lake Dam Inspection Report, Field File #55.15, Key Sequence No: 2160, Town of Star Prairie, St. Croix County, Wisconsin.

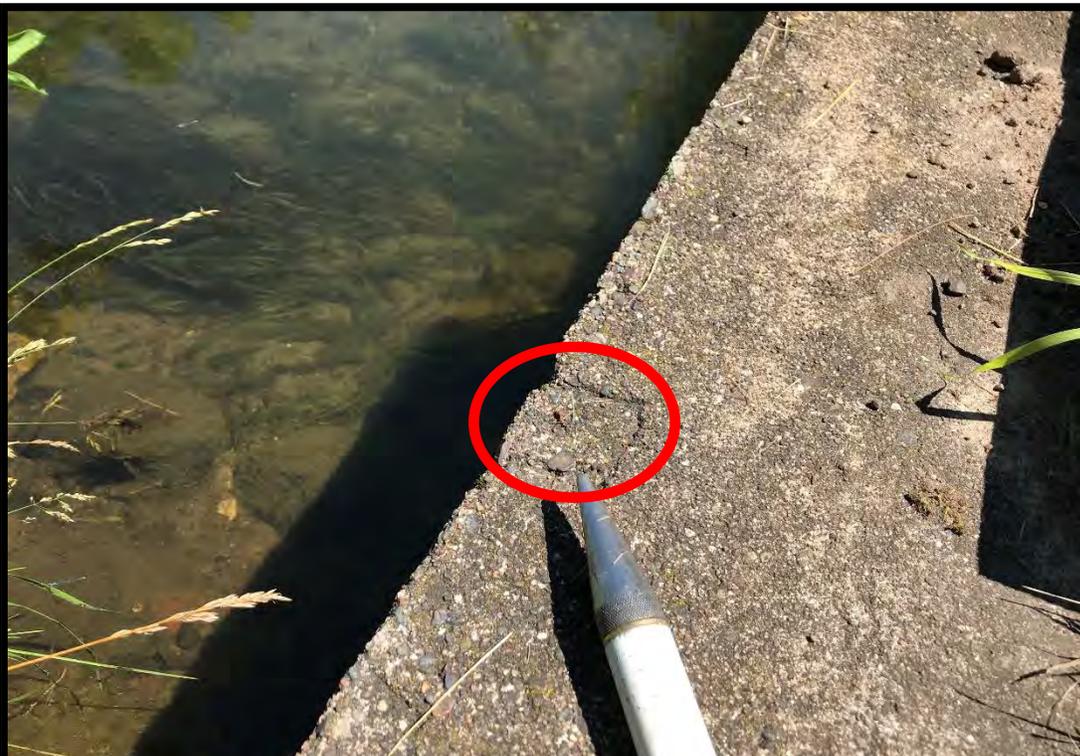
A formal survey was not completed during the inspection, however as mentioned previously, benchmark 632-F was able to be located on the right abutment of the dam. The square cut is worn, however can be found. According to the Department's records, this benchmark has an assumed elevation of 98.76-ft. Local Datum. The Department recommends that each dam have at least two permanent benchmarks, one on and one off the dam in a nearby location. The benchmarks should be referenced using the NAVD88 datum. Additionally, the staff gages for the dam, which are used to ensure that the ordered water levels are maintained, should be resurveyed and verified for accuracy.

Benchmark 632-F, Square Cut on Right Abutment (Not Surveyed)

The Department requires at least two permanent benchmarks be installed for each dam. It is recommended that one benchmark be located on and one off the dam in a nearby location. Benchmark 632-F was located during the July 11, 2019 inspection. The Department recommends this benchmark be resurveyed and be replaced with a

more permanent monument as the square cut is rather worn. Each benchmark should be referenced using the NAVD88 datum. In addition to the establishment and verification of the benchmarks, the staff gages should be verified. This will ensure that the ordered water levels are being maintained by law and allow for the Cedar Lake Protection & Rehabilitation District to operate the dam appropriately.

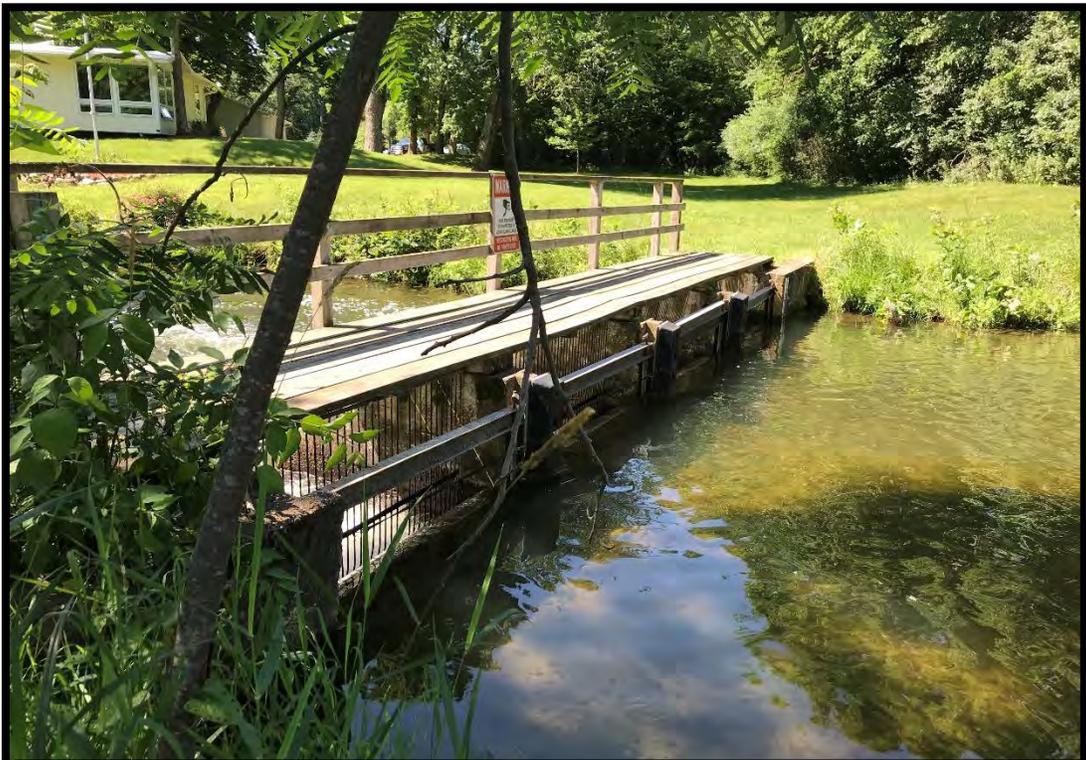
During the inspection, it was noted that rubber bumpers were installed on the upstream faces of the piers. This was likely to protect the dam from debris, ice, or other obstructions. It also appears to serve as part of the stop log slot. The bumpers are connected to steel members which are fastened to the concrete piers.

2-3-inch in diameter trees were observed at the left abutment area. It is recommended that the trees be removed to prevent root growth and invasion at the abutment. In general, the vegetation appeared to be maintained adequately. It is recommended that the lake district continue to maintain and remove vegetation within the immediate vicinity of the Cedar Lake Dam.

Upstream View of Cedar Lake Dam. Note Bumpers on Piers & Tree at Left Abutment

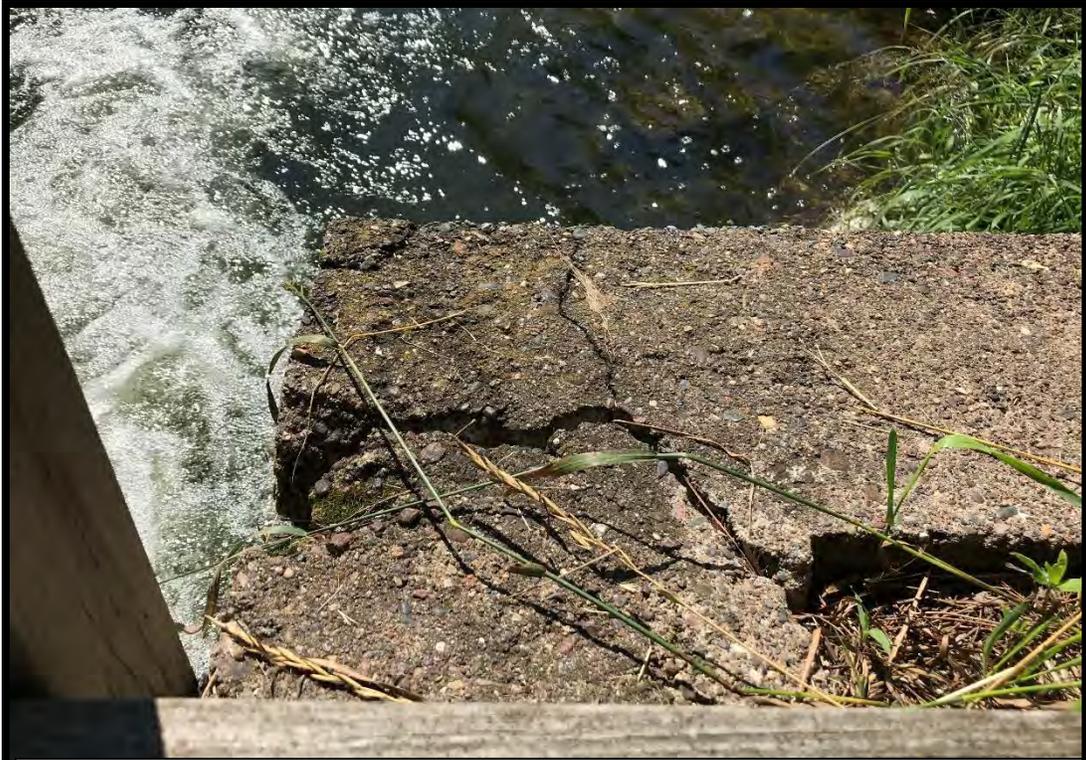
The right abutment of the dam does contain concrete deterioration, but not as significant as the left abutment. The concrete piers, between each stoplog bay, have also sustained significant scour and spalling mainly at the surface of the tailwater downstream. This area is also susceptible to freeze thaw, with the exposed aggregate, and should be repaired in a timely manner.

Significant Cracks and Concrete Deterioration at Right Abutment

The Cedar Lake Dam has sustained significant concrete deterioration since construction in 1949. The Department recommends that the Cedar Lake Protection & Rehabilitation District hire a professional engineer to complete a thorough review of the concrete and determine appropriate repair/reconstruction measures. Particular areas of interest include the left and right abutments and the downstream portion of the piers.

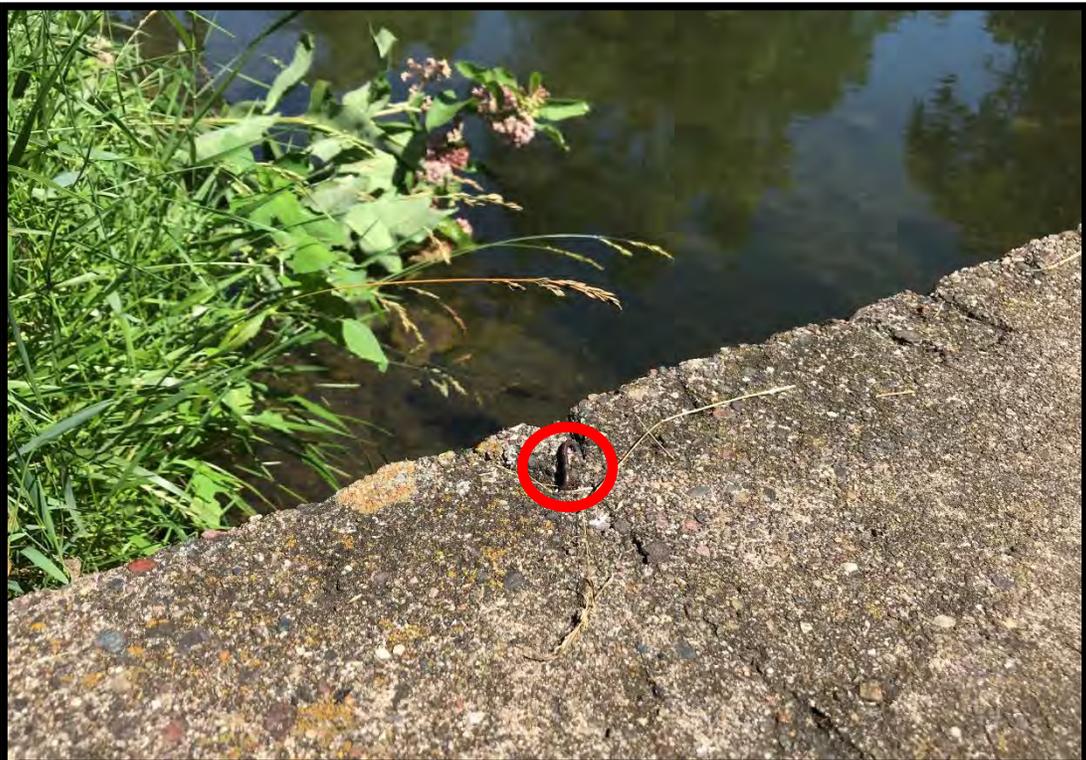
The condition of the left abutment is rather serious. This area has been and is highly susceptible to the freeze thaw cycle which may cause concrete to deteriorate at a faster pace. The concrete in the piers and abutments of the Cedar Lake Dam appear to be the original from 1949. It is not known if the concrete was reinforced, however a few steel pins on the concrete surface were found, indicating that the concrete may have been.

Steel pin found at Right Abutment. May be indication of Reinforcement.

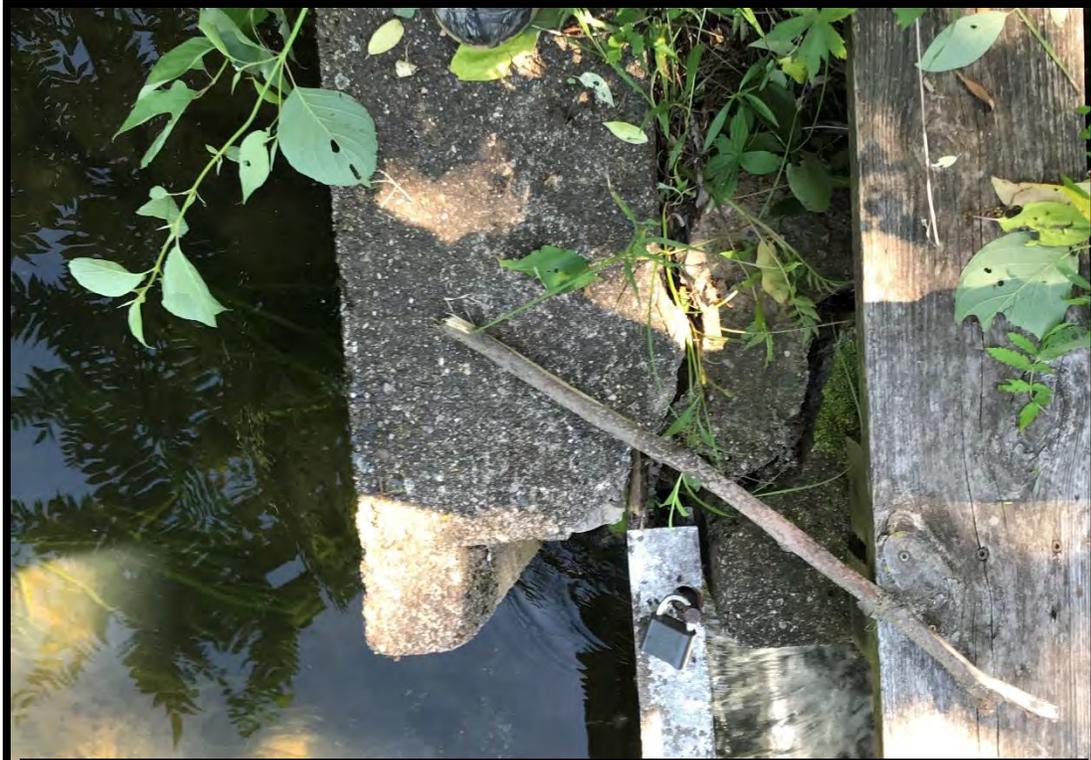
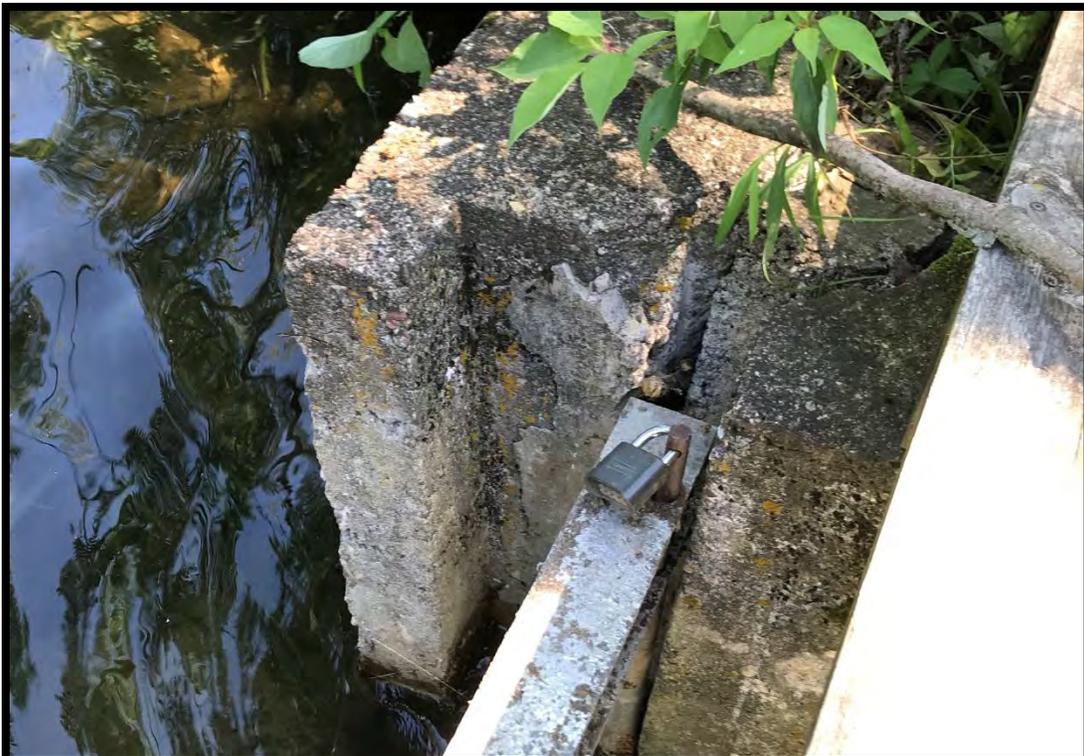
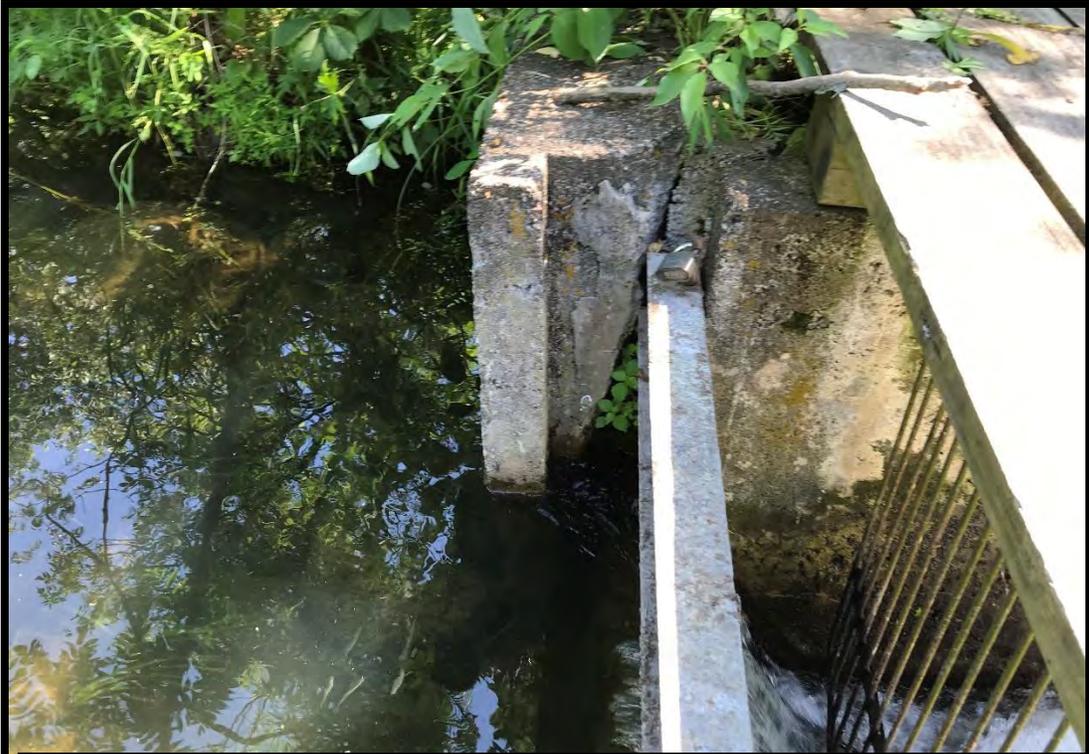
A major portion of the inspection and discussion focused on the current condition of the concrete. The most notable deficiency was observed at the left abutment, referenced from left to right looking downstream. The abutment has a large transverse crack, allowing for movement of the concrete upstream. The concrete deterioration at the left abutment likely occurred years ago and attempts to repair it have been conducted. This is evident by a concrete portion located within the exposed crack, which appears to have broken away from the parent concrete material.

Significant Cracks and Concrete Deterioration at Left Abutment

Provided that the concrete has been in place for 70 years, it is recommended that soundings or cores be taken to test the adequacy of the parent concrete material. If suitable, it may be able to be used for resurfacing of the concrete. If not, then a full replacement may be necessary.

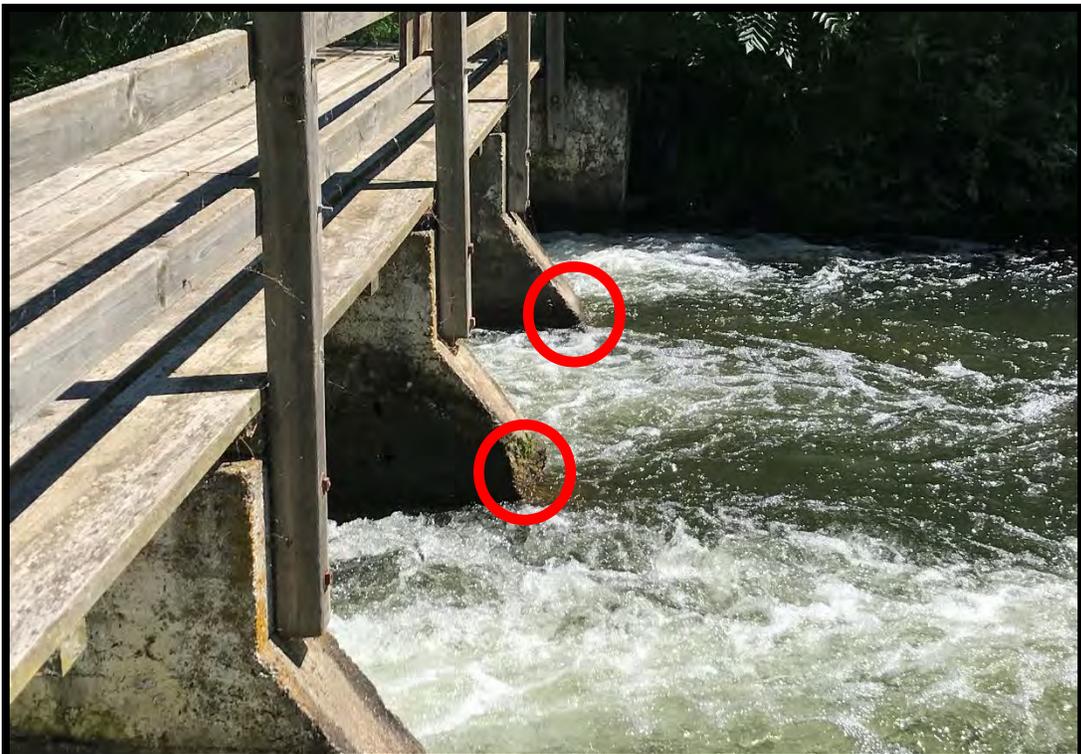
Significant Scour and Spalling on Downstream Piers
