Analysis of Management

Targeting *Myriophyllum spicatum*  
(Eurasian watermilfoil)

Cedar Lake

*August, 2021*

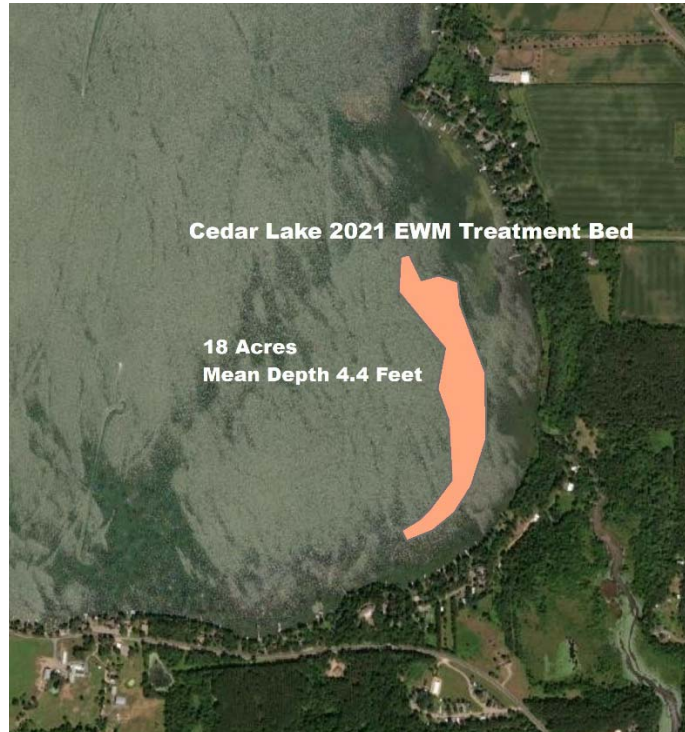
**Figure 1: Map showing the EWM treatment bed delineated in August 2020 and adjusted May 2021 after bed evaluation.**

Cedar Lake, Polk and St. Croix County has had Eurasian watermilfoil (*Myriophyllum spicatum*) since 2015 (year of discovery). On June 8, 2021 an 18-acre bed of EWM was treated with ProcellaCOR (Florpyrauxifen-benzyl). This is the second treatment with ProcellaCOR in Cedar Lake, with two beds treated in 2019 (one of which is contained within the 2021 bed). The bed was delineated in August 19, 2020 and was checked on June 3, 2021 to evaluate EWM was active and to verify boundaries of the bed, which were adjusted mainly for depth. Figure 1 shows the map of the treatment and table 1 summarizes the bed parameters and conditions during treatment.

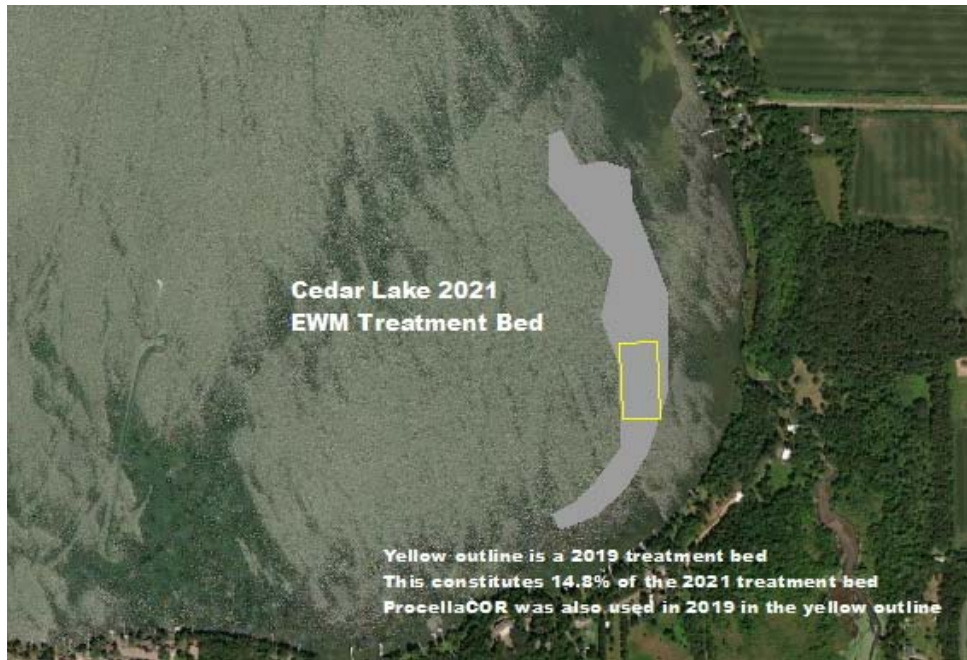
The 2021 treatment bed contains all of one of the two beds treated with ProcellaCOR in 2019. This small bed had a less effective result than the larger bed treated in 2019. The EWM had spread from the 2019 treatment area that led to the delineation of the 2021 treatment bed. The 2019 bed is 14.8% of the 2021 bed. Figure 2 is a map showing the 2019 bed contained within the 2021 bed (yellow outline).

**Figure 2: Map showing one of two 2019 treatment beds overlaying the 2021 treatment bed.**

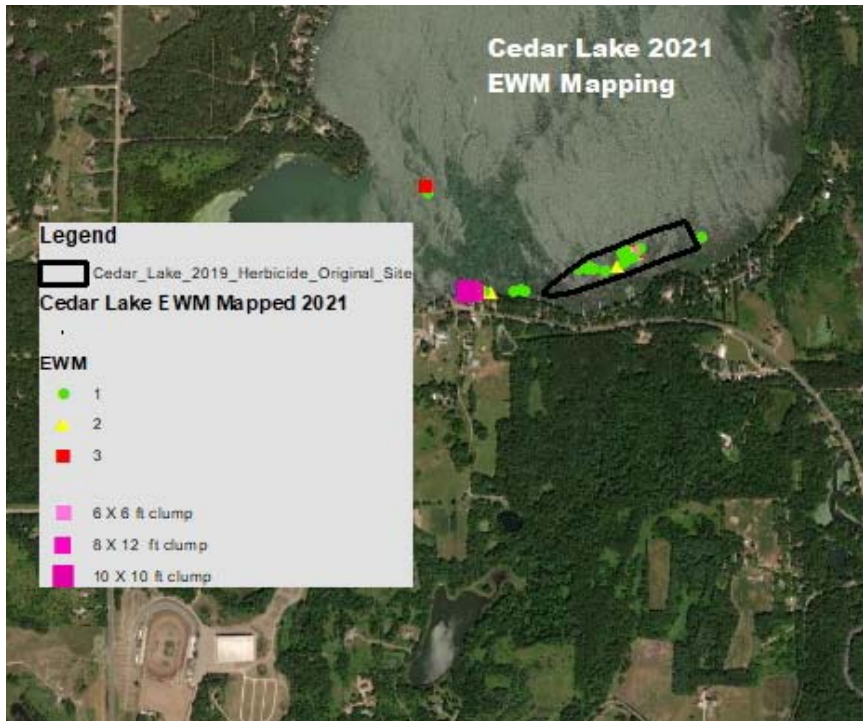
Figure 4 shows the location of EWM recorded. There were three key areas of EWM. One of them is the treatment bed from 2019. The EWM is starting to return slowly in this bed, with a small area with fairly dense EWM growth and less dense growth scattered in other areas of this bed. The other two areas of EWM are new. One is in front of a restaurant that may have high boat traffic. The other is in a shallow area quite far from any shoreline area.

**Figure 4: Map of EWM locations and density in June and July, 2021. Water clarity was too poor to evaluate in August.**

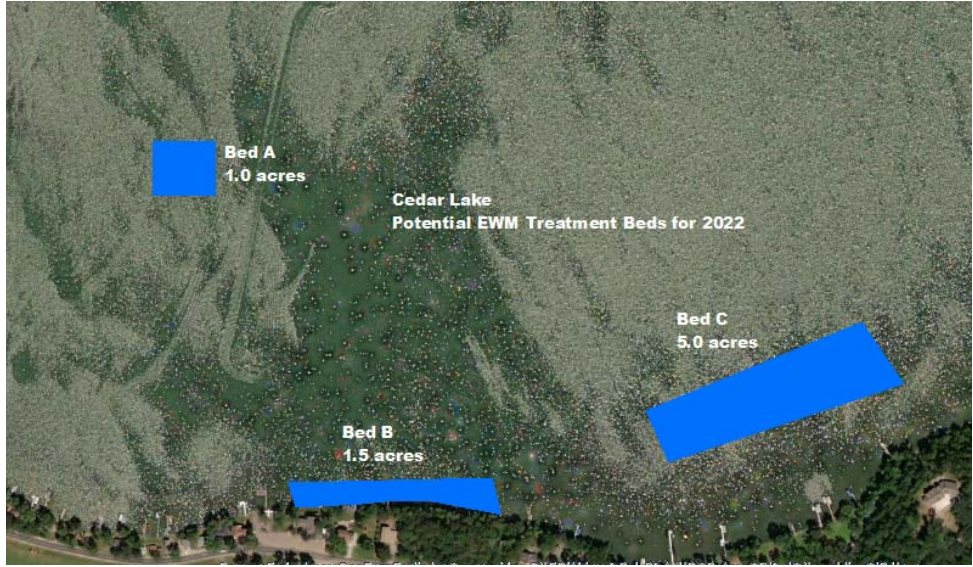
For purposes of management planning, the areas with fairly dense EWM coverage were delineated into beds to consider for herbicide application. There were three beds delineated totaling 7.5 acres which are shown in Figure 5 with the area of each bed. Bed B did have some hand pulling occur in July 2021 but remained quite dense when observed in August 2021 after hand pulling occurred (see hand pulling section in this later in this analysis). An August update was not possible due to low water clarity, so there may have been more EWM than was last recorded in July.

**Figure 5: Map of delineated EWM beds that may be considered for herbicide application in 2022.**

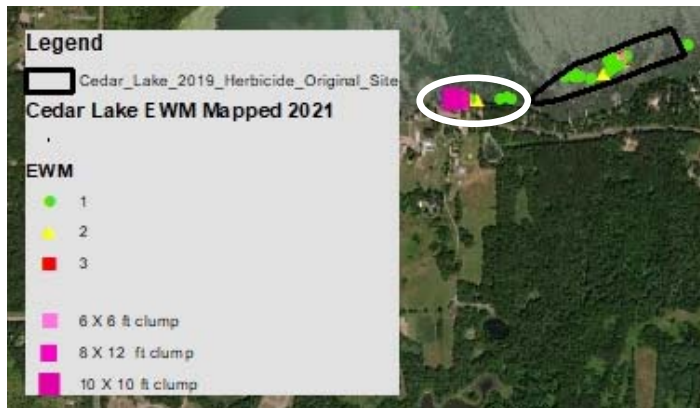
On July 22, 2021 a dive team was contracted to address EWM mapped in June and July in areas of concern. The hand pulling occurred in a dense (small) bed in front of a set of piers in front of a restaurant (see white circled area on the map: figure 6) and then moved to the east to remove more scattered clumps. The APM lead for Cedar Lake observed that the team had better success in scattered areas than in the dense areas. This was likely due to needing to spend more time in one area, resulting in more cloudy water from disturbing the bottom substrate, reducing the ability to discern EWM. The amount of EWM by weight and/or volume was not recorded. The EWM was loaded onto a pontoon boat and offloaded to a trailer and composted at a designated site.

**Figure 6: Map showing hand pulling location**

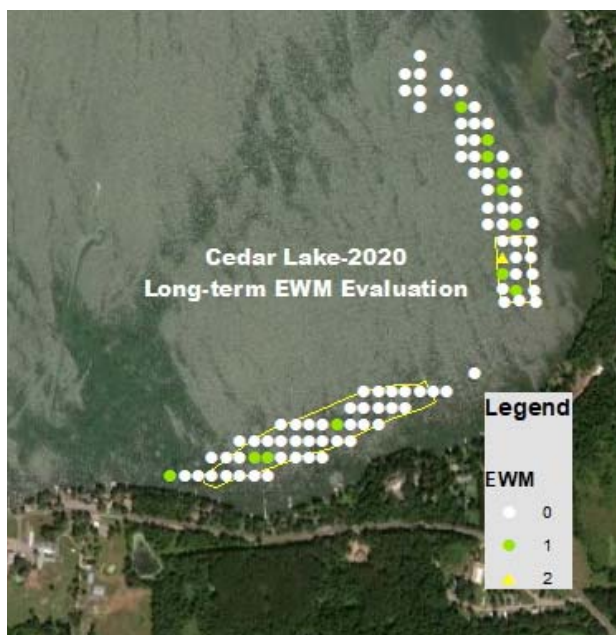
**Figure 7: Map showing the results of the 2020 long-term survey.**

This survey shows a decrease in the frequency of EWM within the grid. This reflects the reduction in EWM from the herbicide treatment in 2021 (13.4% to 6.25%), which is where most of the 2020 frequency occurred. The original treatment bed (2017) is in the grid as well and since EWM is returning to that older bed, the frequency was higher than zero. The frequency in 2021 is higher (11.6% vs 6.25%) with the added sample points because they were added to areas with EWM growth. This indicates that the EWM is spreading slowly in Cedar Lake, although it is still confined to the south end of the lake. Figures 7 and 8 map the results of the long-term surveys from 2020 and 2021 respectively.

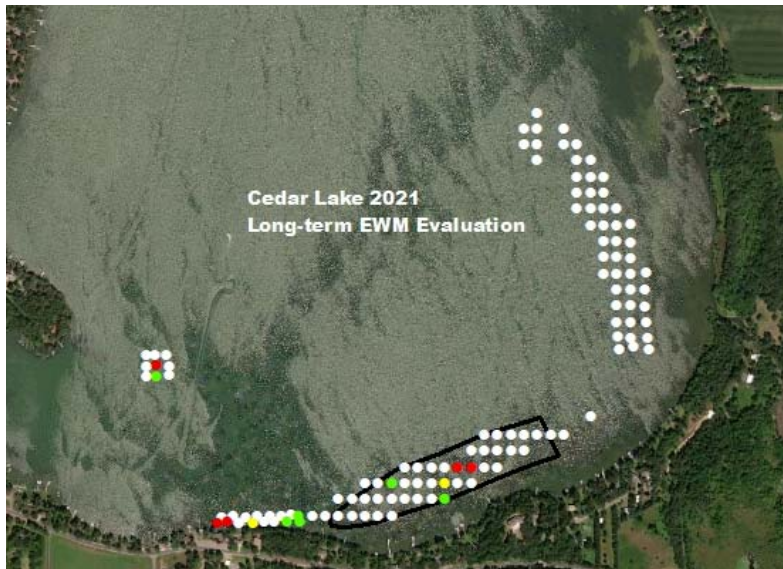
**Figure 8: Map showing the results of the 2021 long-term survey, including the added 2021 sample points.**
